PHOTOGRAPHIC INTELLIGENCE REPORT

LIQUID ROCKET ENGINE TEST FACILITY

OMSK, USSR

CIA/PIR 71007

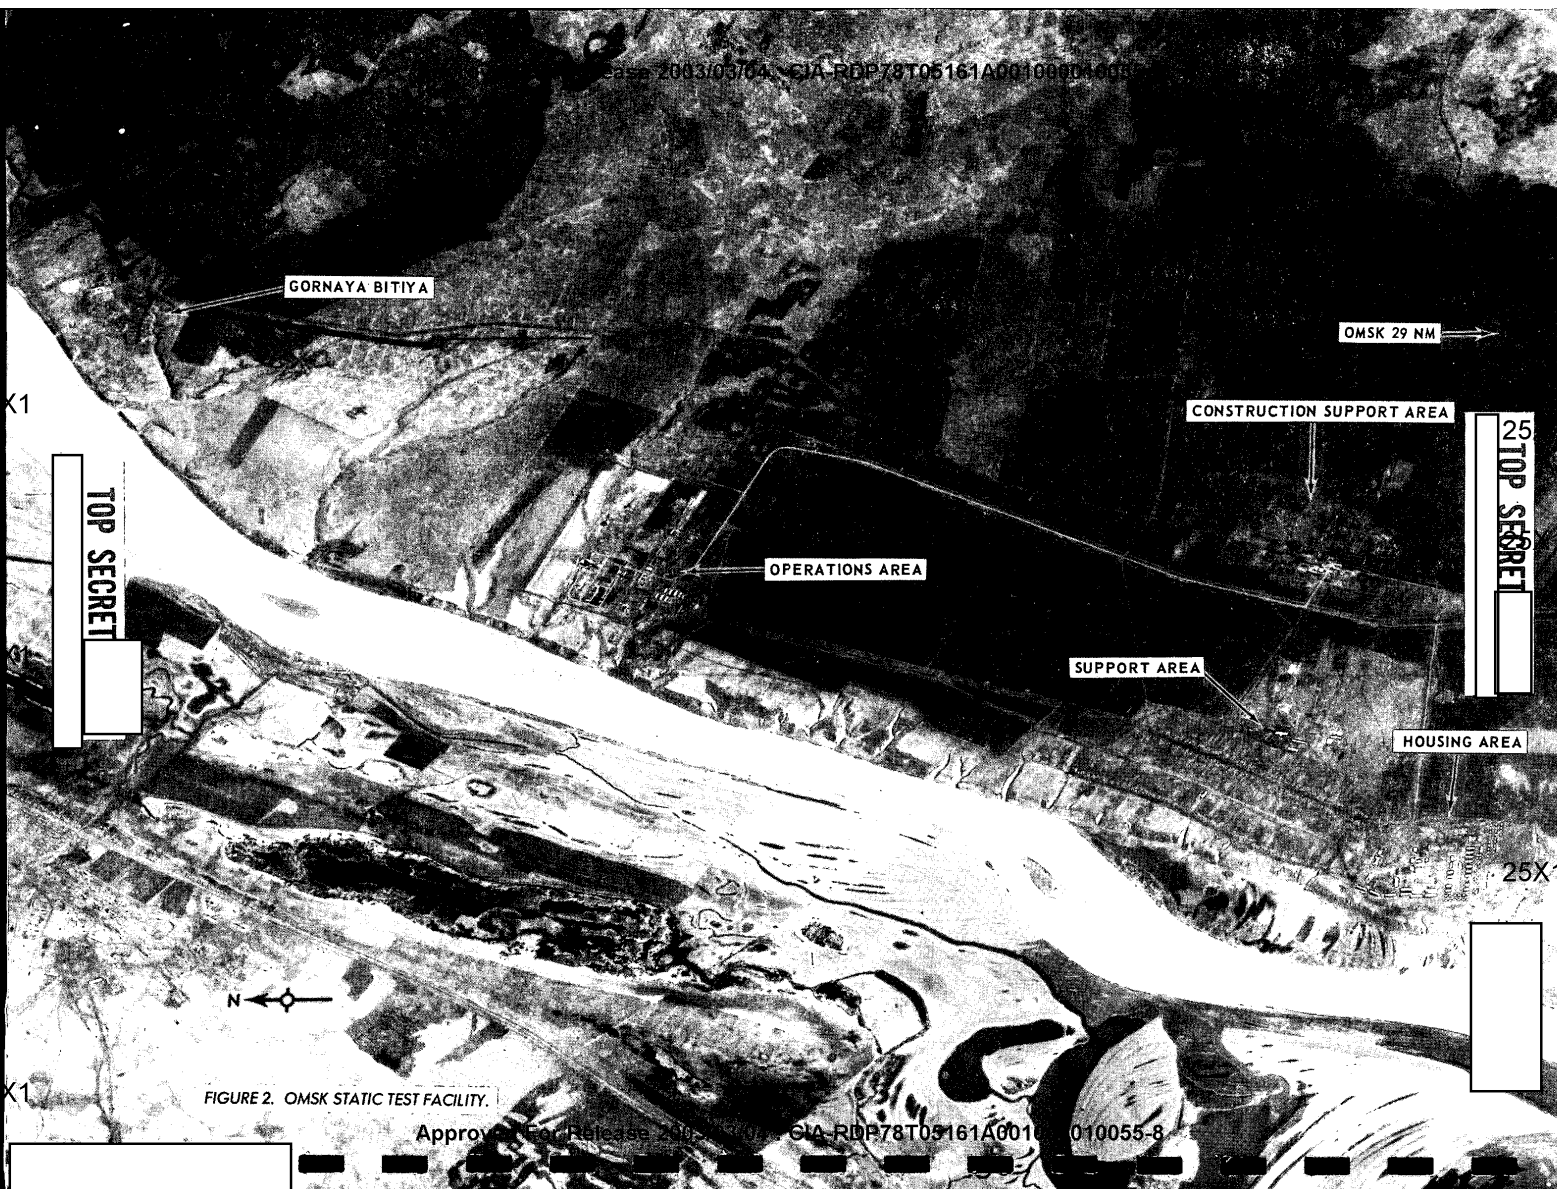
FIGURE 2. OMSK STATIC TEST FACILITY.

The Omsk Liquid Rocket Engine Static Test Facility [ ] is located at 55-25N 73-17E, 29 nautical miles (nm) north of Omsk and 2 nm south of the village of Gornaya Bitiya (Figures 1 and 2). It is positioned on the southeast side of the Irtysh River, a major tributary of the OB. The facility was first observed on [ ] at which time it was under construction. Numerous subsequent coverages permit the establishment of accurate construction chronologies for major portions of the installation.

The facility, served by a rail line which extends north from Omsk, consists of three functional areas designated as follows: the operations area, the housing area, and the construction support area (Figure 2). The rail line serving the facility divides into two branches just south of the construction support area, with one branch serving the support area and the other continuing into the operations area. An all-weather road also interconnects all three areas of the facility. Two vertical test stands in the operations area are the primary features at this installation. Vertical Test Stand No. 1 encloses a single test position which is believed to have been operational since the fall [ ]. Vertical Test Stand No. 2, still under construction, appears to be a two position structure.

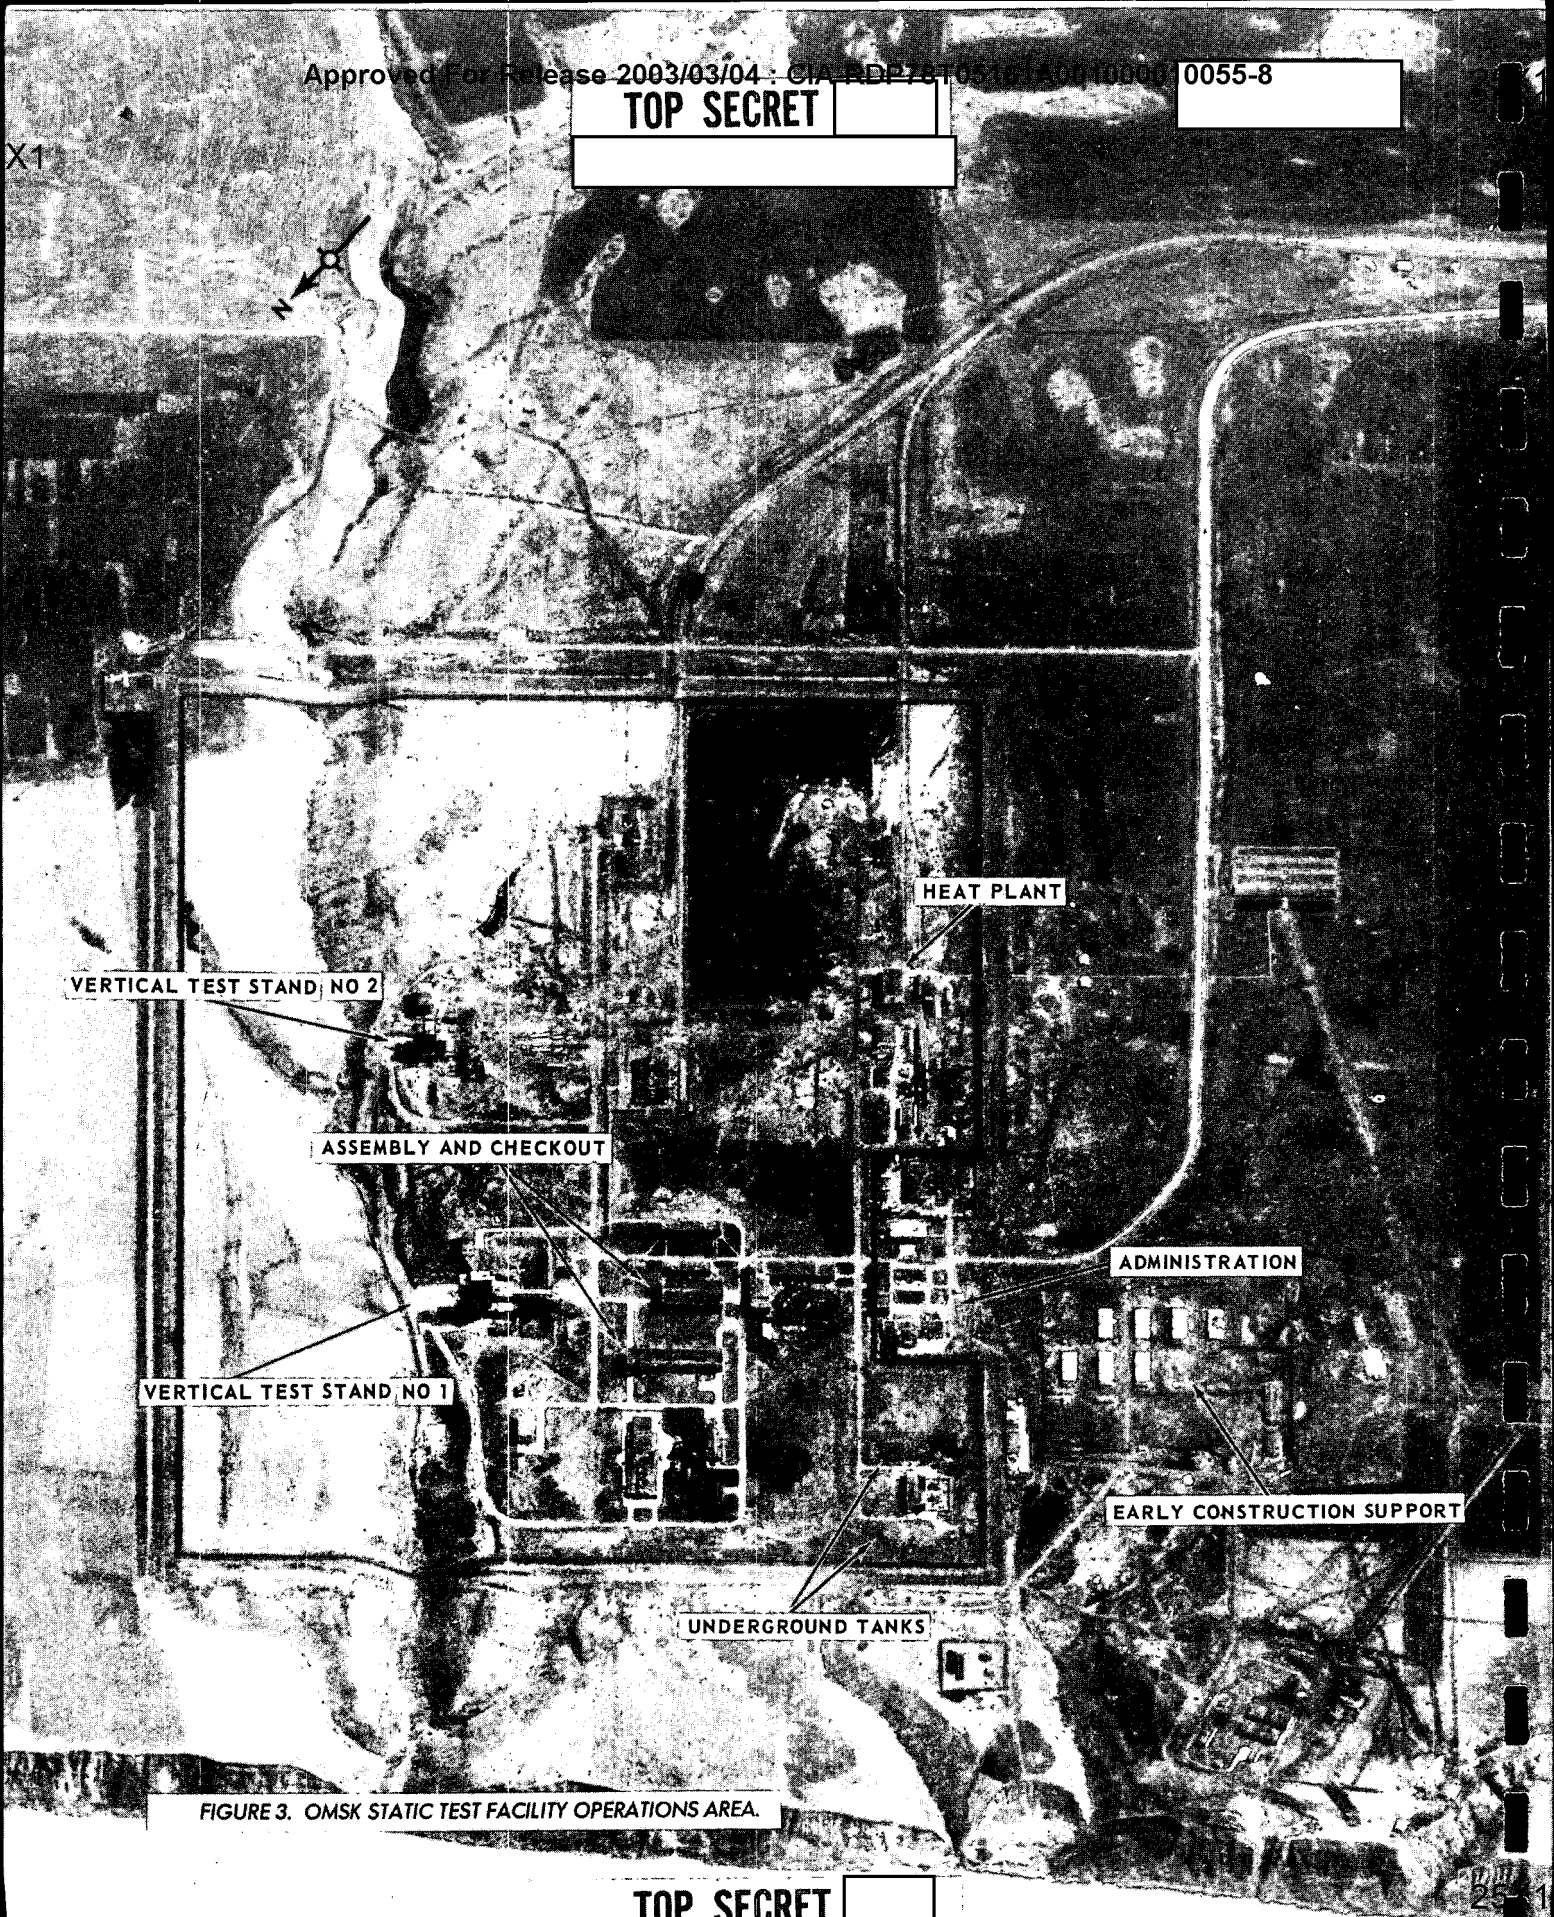
FIGURE 3. OMSK STATIC TEST FACILITY OPERATIONS AREA.

OPERATIONS AREA (Figures 3 and 4)

The operations area is served by four spurs from the branch rail line and also by the main access road from the housing and support areas. Most of the buildings are located within a single security fence; however, administration, construction, support, and certain miscellaneous buildings are outside of the secured area. Within the fenced area are 33 buildings with a total floor space of approximately 254,000 square feet. Including those buildings outside the fence line, the entire area contains 45 buildings with a total floor space of approximately 363,000 square feet. Eight buildings were completed on or before [redacted] The rest were completed by [redacted] with the exception of Vertical Test Stand No. 2 and its associated control buildings. The operations support buildings and structures are listed in detail on Table 1 and keyed to Figure 4.

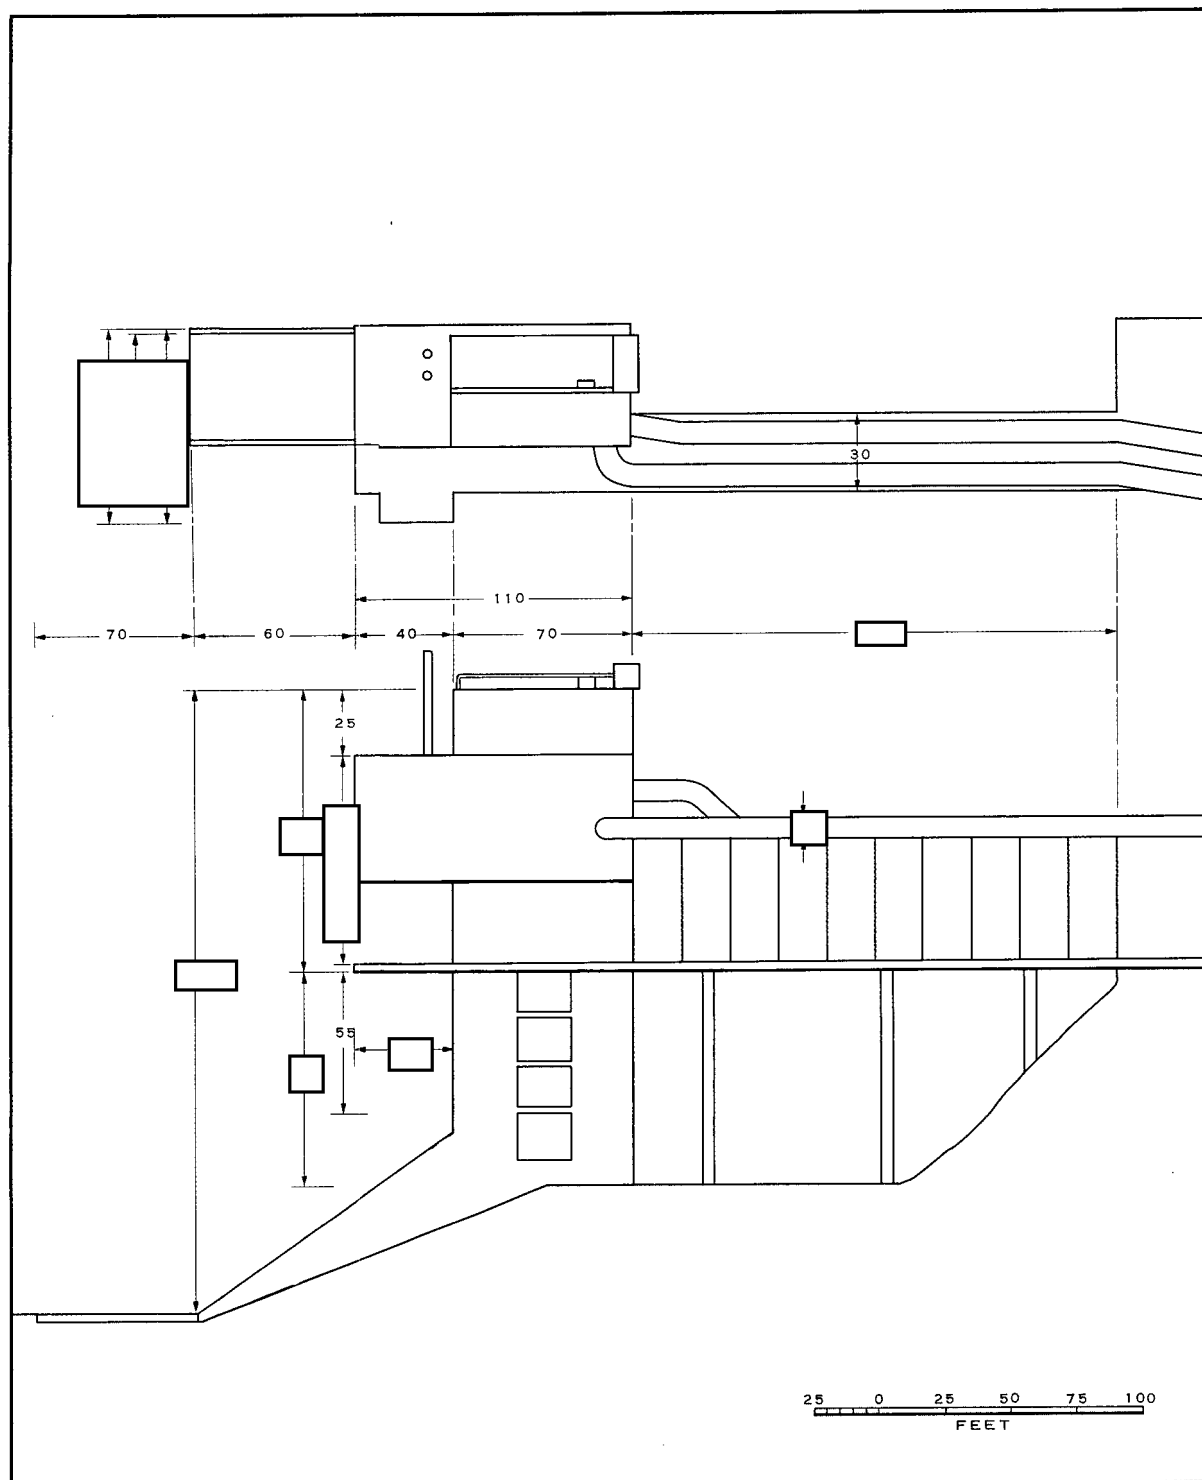
FIGURE 5. VERTICAL TEST STAND 1, OMSK.

Vertical Test Stand No. 1 (Figures 5, 6, and 7)

X1 This single position test stand is located on the south side of a deep ravine in the northeast section of the operations area. The super structure of Vertical Test Stand No. 1 measures [ ] and is approximately [ ] Access to the stand is via a 30-foot wide approach ramp which approaches from the south and enters the northwest side of the stand approximately [ ] above the base; access to the base of the stand is served by the original construction road. Two large pipes approximately [ ] and positioned above the access ramp are connected to the side and back of the stand. These pipes angle away from the access ramp at a 30 degree angle. This particular pipe configuration is the only one of its kind at the known Soviet Liquid Static Test Facilities. The precise use of these pipes is not discernible at this time, although they appear to be used for exhausting of some type.

X1 An observation/control building, measuring [ ] and situated 115 feet east of the stand, has six windows on the westerly side apparently for test observation purposes. A large probable control cable trough topped by a small tubular pipe extends from the base of the observation building to a point midway up the east side of the stand. In close proximity to the stand are various assembly, checkout, and support buildings.

X1 Construction roads to the test stand site were evident [ ] However, the first indication of the stand superstructure appeared on [ ] The stand appeared to be complete on [ ]

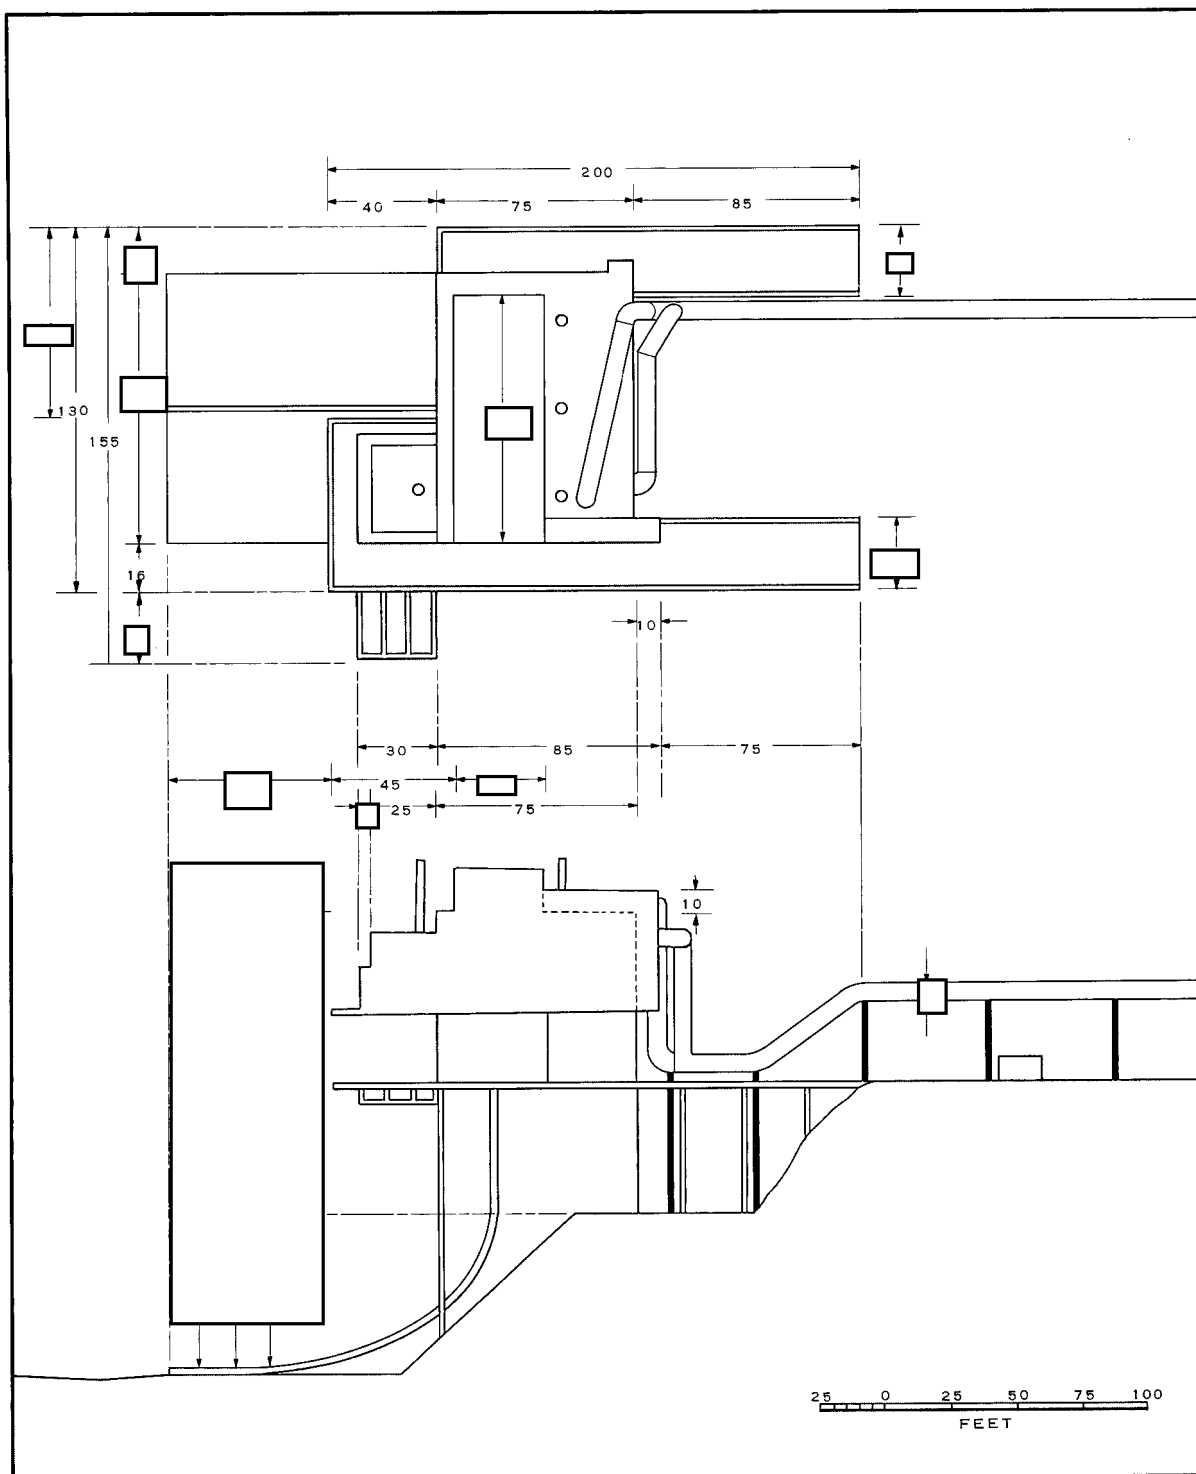
FIGURE 8. VERTICAL TEST STAND 2, OMSK.

Vertical Test Stand No. 2 (Figures 8, 9, and 10)

X1 Vertical Test Stand No. 2, which is still under construction, is located approximately 1,000 feet east of Vertical Test Stand No. 1. This second stand measures [ ] and is approximately [ ] Two access ramps approach the stand from the rear and run along the east and west sides. These ramps join the stand approximately 50 feet above the base of the structure and their presence indicates the existence of two positions. A large pipeline enters the rear of the stand west of the right access ramp. It appears to originate at a possible pump house approximately 1,400 feet south of the stand and may be a water line to cool the blast deflectors or a steam line for simulated altitude testing. The latter is taken into consideration due to the proximity of the heat plant to the possible pump house (Figure 4, Buildings 21 and 22). There

In close proximity to Vertical Test Stand No. 2 is an observation/control building measuring [REDACTED]. It is situated [REDACTED] east of the test stand on the side of the excavation and appears to be connected to the stand by cable trough similar to those observed at stand No. 1.

Excavation for stand No. 2 was begun between [REDACTED]

[REDACTED] the superstructure was readily discernible. The following observations on construction status were noted on [REDACTED] when the stand appeared to be approaching completion.

1. The blast deflector closest to Vertical Test Stand No. 1 appeared to still be under construction.
2. Access roads to the stand appeared to be unimproved.
3. Construction support buildings and materials remain evident throughout the area.
4. No sign of a blast mark at the completed deflector has been observed.

If the existing support buildings for stand No. 1 are utilized, the stand could be used by late [REDACTED]

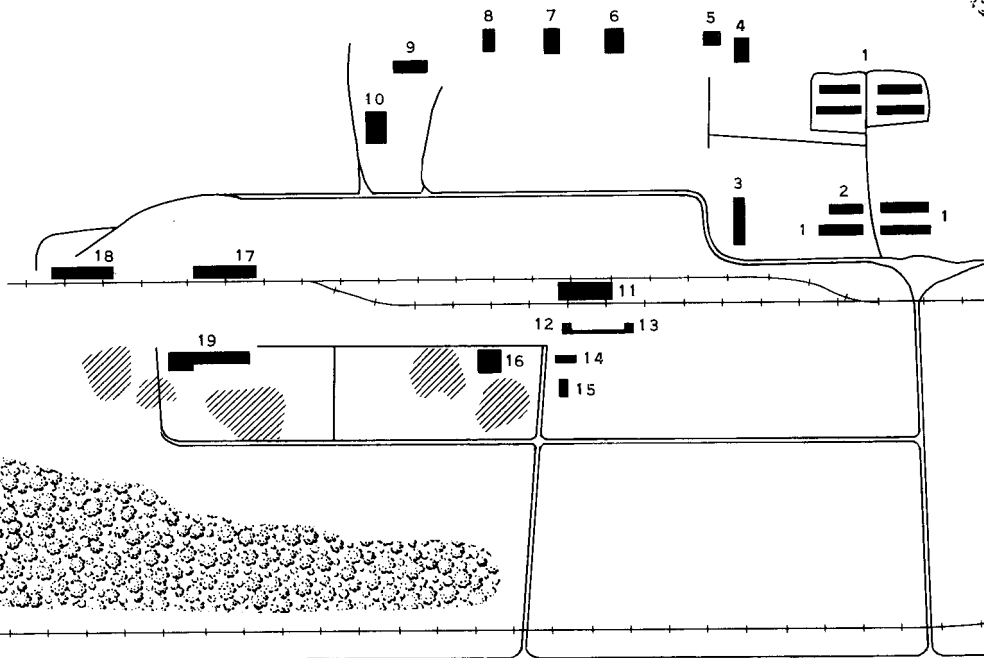
FIGURE 14. OMSK STATIC TEST FACILITY CONSTRUCTION SUPPORT AREA.

CONSTRUCTION SUPPORT AREA (Figures 13 and 14)

The construction support area lies 3 nm southeast of the operations area via the main access road. No security fencing is visible at the area. The area is served both by the eastern branch of the rail line and by the main access road from the housing and operations area.

Twenty-five buildings and structures in the area account for [redacted] square feet of floor space (Table 3 keyed to Figure 14). The buildings, most of which appear to be used for storage, are single story structures near the rail spur and main access road. A cement batch plant is also located in the area (Figure 12, Items 12, 13, and 14). Extensive use has been made of open storage areas between the rail spur and the main access road (Figure 11). The major portion of this area was complete by [redacted] with two additional units being completed by [redacted] and one final structure being erected as late as [redacted]
